⑬ (急) 大良地区 (愛媛県宇和島市吉田町奥浦)

被災  
H30/7/7

本復旧開始  
R2/1/29

復旧完了  
R3/2/28

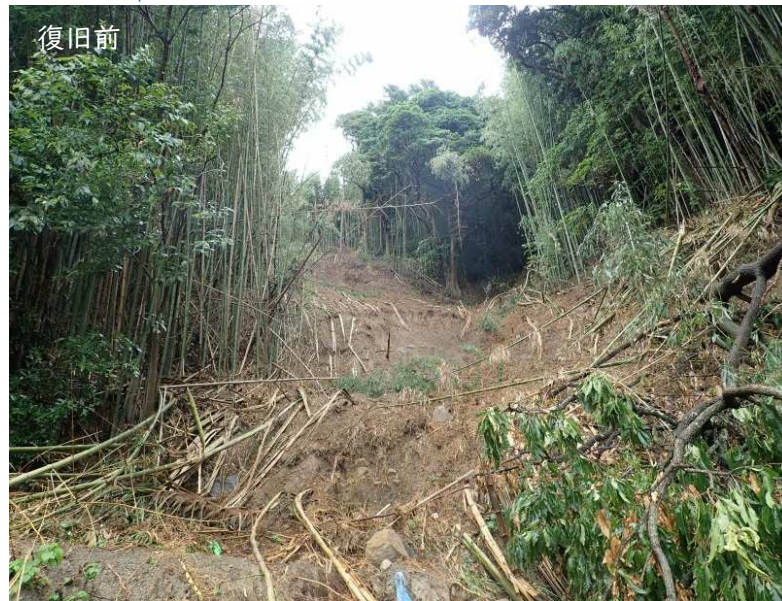
崖崩れ  
高さ：約 70m  
長さ：約 100m  
幅：約 15m
